# THE PRESERVATION OF ST PAUL'S CATHEDRAL & OTHER FAMOUS BUILDINGS

A TEXT BOOK ON THE NEW SCIENCE OF  
CONSERVATION, INCLUDING AN  
ANALYSIS OF MOVEMENTS IN  
HISTORICAL STRUCTURES  
PRIOR TO THEIR  
FALL

WILLIAM HARVEY

1925

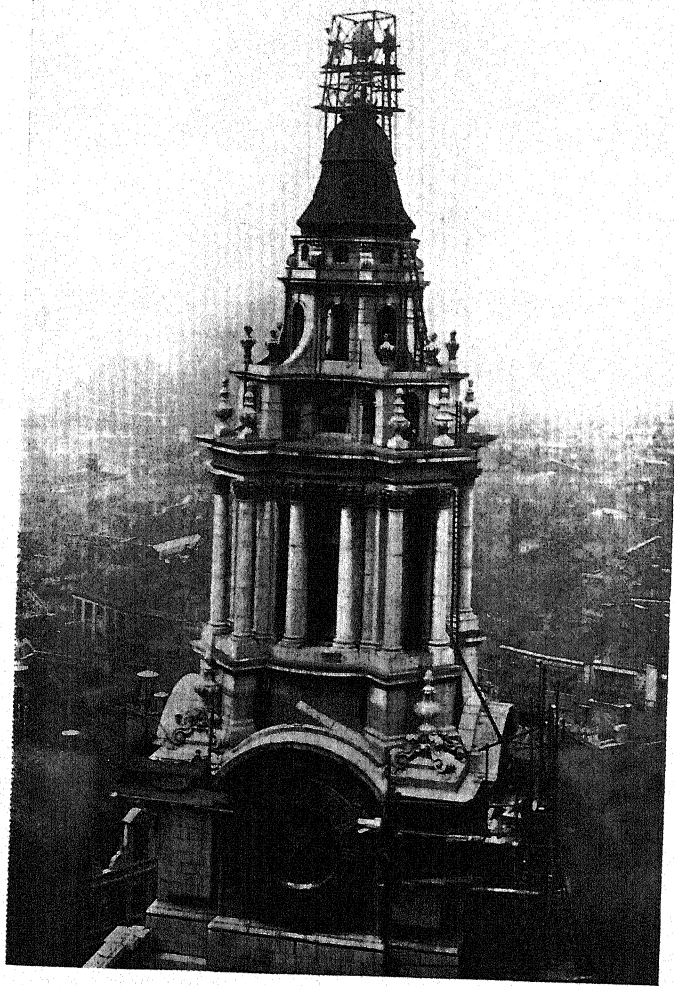
FIG. 29. The South-West Tower of St. Paul's. Years ago the tower was reported out of perpendicular, but this fact was not associated with the general drift of the arches and buttresses throughout the building towards a point of weakness. See also figs. 17, 18, 55, 64, 65, and 70.

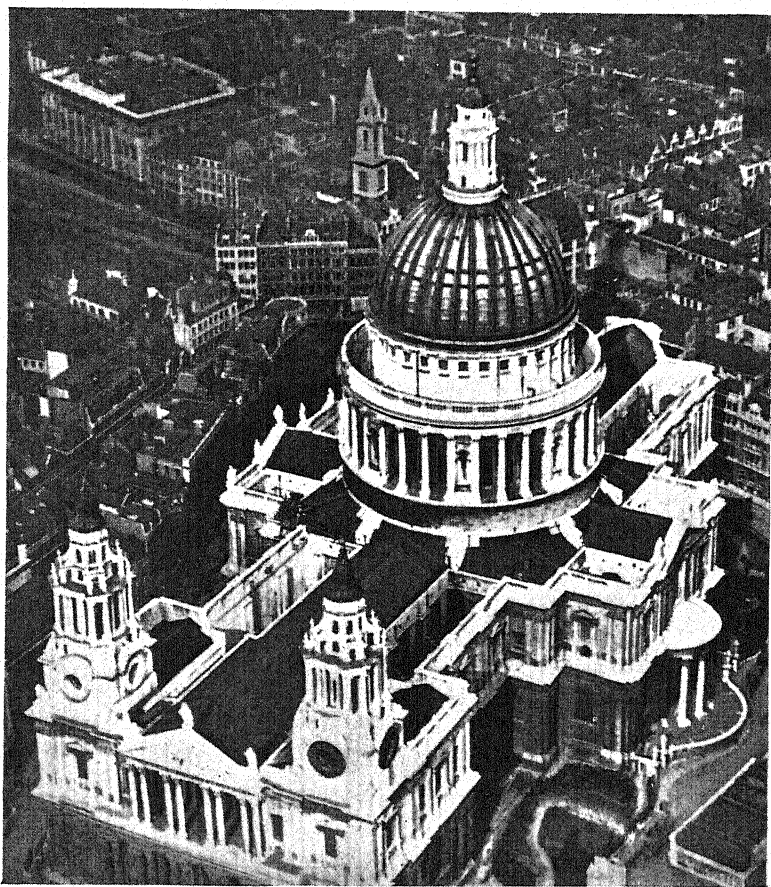
FIG. 34. This view of St. Paul's is interesting as showing how the drum bearing the great dome is in turn supported on its eight piers. The view also reveals the true walls of the nave, transepts, and chancel behind the screen walls which alone are seen from the street.

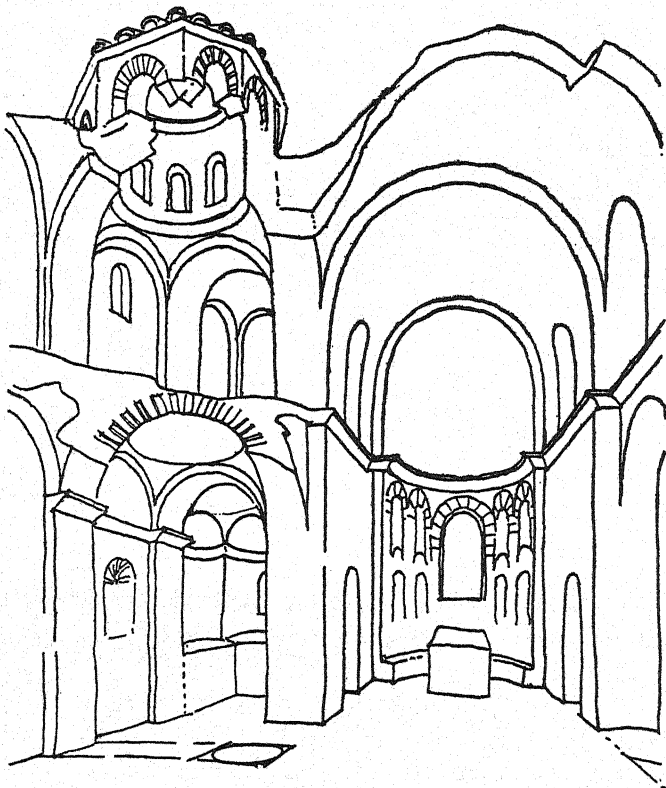
FIG. 58. Ruined Church, Castle Rock, Mistra, Greece. Small dome hanging in the air stuck together with tenacious mortar. From a sketch by the author.
